Vijecnica Sarajevo

City Hall Sarajevo

Obnova Vijećnice

The Restoration of the City Hall

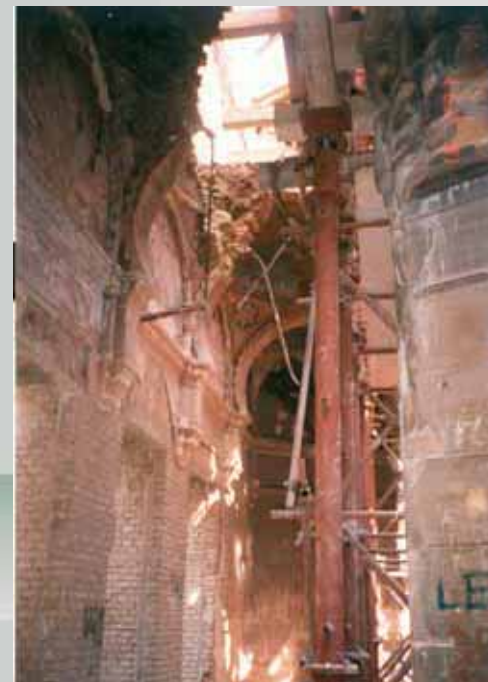
D - Sanirana čelična konstrukcija i spuštenu strop jednim dijelom se oslanjaju na obodne zidove i konstrukciju aule, koja je dio najviše oštećene strukture objekta.

Projektovana je i izvedena teška čelična nosiva skela, sa posebnim masivnim drvenim remenatama, čime je konstrukcija aule prihvaćena. Ovom izvedbom spriječilo se oštećenje na već izvedenim radovima na kupoli i ujedno stvorili uslovi za obnovu strukture aule.

D – The rebuilt steel structure and the descending ceiling lean, partially, on the perimeter walls and the structure of the aula, which is a part of the most significantly damaged structure of the building.

The heavy steel supporting scaffold has been designed and constructed, with special massive wooden straps, with which the structure of the aula has been captured. This labor has prevented damages to the work already carried out on the dome and, simultaneously, created conditions for the restoration of the structure of the aula.
